## TECHNICAL MEMORANDUM

RE: **WORK PLAN ADDENDUM NO. 2**  
**STORM DRAIN STRUCTURE AND SURFACE CLEANUP**  
**NORTH BOEING FIELD**  
**SEATTLE, WASHINGTON**

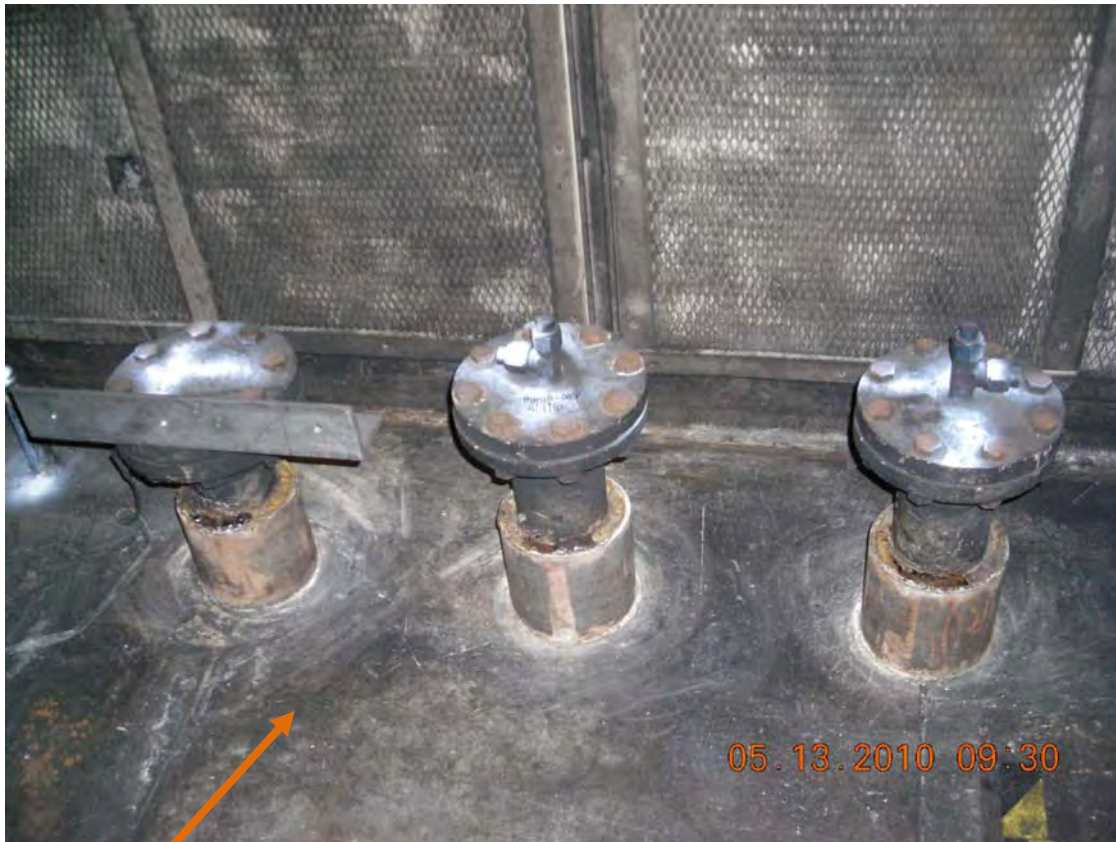
There are 15 steel flanges inside the 3-322 building that historically were connected to fuel or utility piping and are no longer in use. The flanges are typically found in groups of three, as shown on the upper photograph of Figure 1. Asbestos and PCB characterization sampling was initiated after excavation activities described in the Work Plan exposed some of the abandoned fuel piping outside of the 3-322 building. The laboratory analytical results from this characterization sampling are attached to this addendum. The flange covers will not be removed to avoid disturbing the asbestos gaskets.

Typical Flange Configuration

Following removal of the caulking around the flange collars, the contractor will cut off the steel pipe flush with the building floor using cold cut methods. In the case a flange is located with a concrete collar, the collar will be chipped away to allow for the flange to be removed. The flange and all associated parts will be placed into Department of Transportation (DOT)-approved shipping containers and managed as TSCA waste; these materials will also be managed in accordance with asbestos disposal guidelines. Containers will be shipped to the Waste Management NW chemical waste landfill in Arlington, Oregon. After the flanges have been removed, the contractor will backfill the hole in the floor with concrete to create an even level with the building grade.

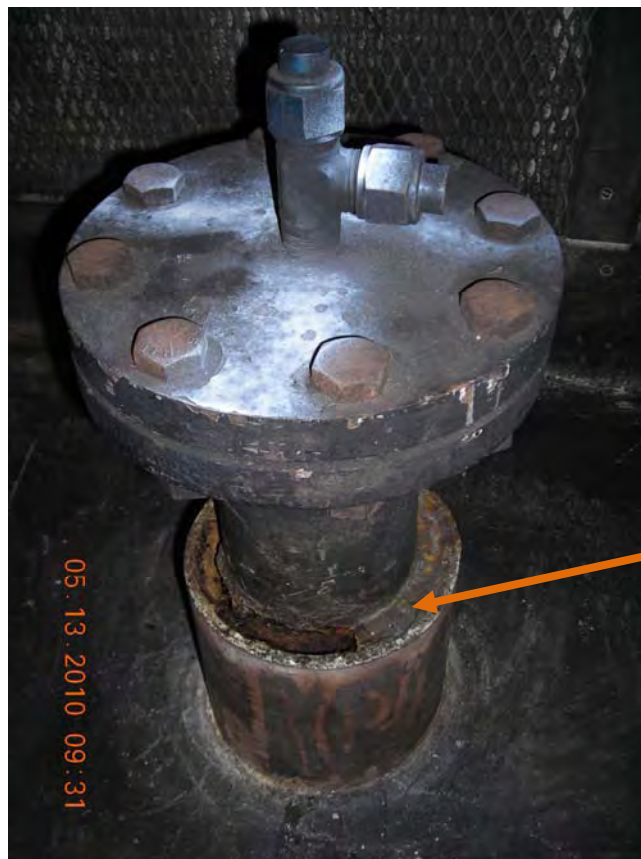
Caulk material typically located around flange collar

NOTE: NORMM previously sampled the caulking material for asbestos and the results were negative for asbestos. NORMM also sampled for heavy metals and results were positive for lead, cadmium and chromium.
